Improving Dabber Buoyancy

I wanted a Dabber because of its size and sail plan and, after much searching, Anam Nan Eilean, (Spirit of the Isles) hull number 688 was found on Islay off the West Coast of Scotland.

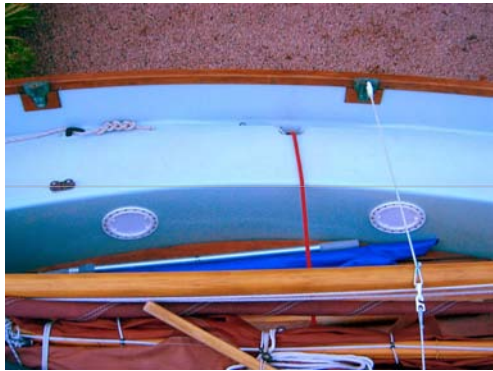
With relatively little water aboard she soon lost floatation and was swamped. In this state the gunnels were only just at the surface and there was barely sufficient buoyancy to float the hull. Recovery was impossible because she rolled like a barrel and in any case could not support crew.

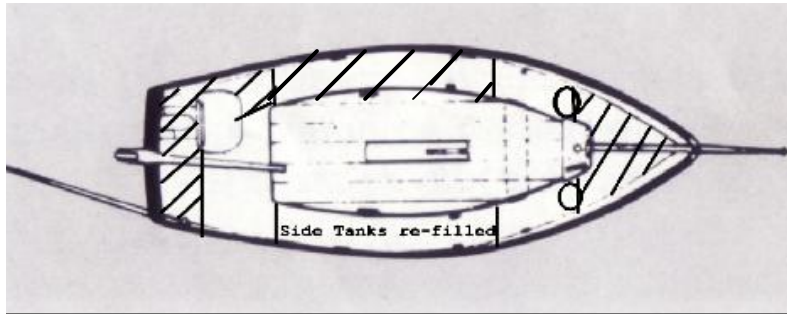
Stern locker

With the side chamber and bow modifications I found that the stern would still dip when weight was shifted aft. The solution was to build an internal bulkhead by bonding fibreglass sheet within the rear locker across the transom and on the port side, to form a cavity to contain the buoyancy foam (see illustration below – hatched areas indicate where there is now solid buoyancy).

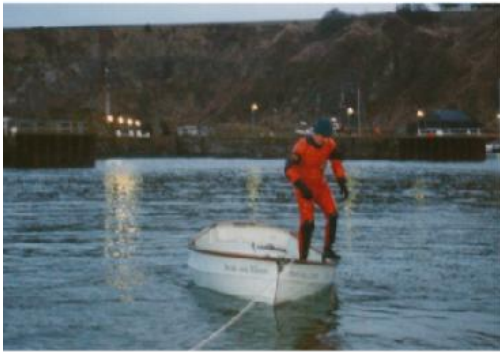
Re-testing with buoyancy added (photo – below left). Full of water it took two of us bouncing on one gunnel to persuade her to capsize. Turning her back was easily accomplished by one person by pulling on the centre plate. (Note testing was without sails)

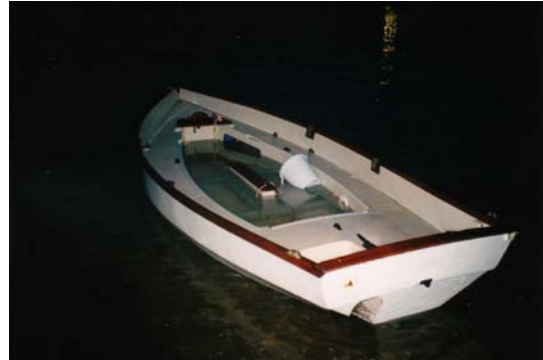
Freeboard

Swamped (photo - above right) but still with plenty of freeboard. Recovery from this state should be possible depending on conditions. Note both the above pictures were taken during testing prior to the stern improvements.
