What to look for when purchasing a second hand Drascombe by Tim Pettigrew

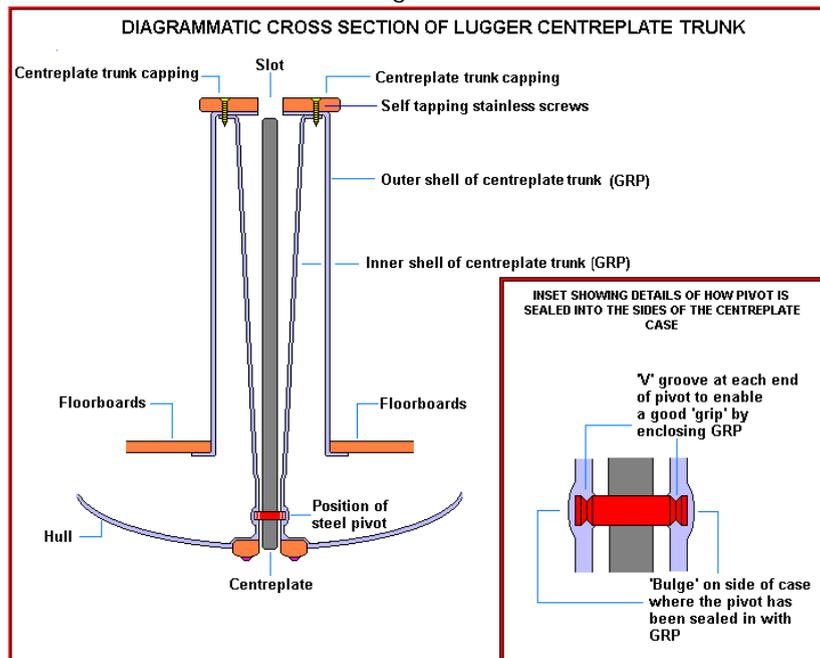
Figure 1

If the boat is old it is likely that the galvanising on the centre-plate will have corroded away in places and the mild steel will have rusted. The crucial area to examine is the leading edge of the plate as this is constantly immersed in water when the plate is raised or

lowered. I have seen an example of one plate that looked immaculate along the top edge but was completely eaten away by rust along the lower edge.

Inspection is difficult but the easiest option is to crawl beneath the boat with a torch where, depending on the design of the trailer, it may be possible to see the edge of the plate by looking up into the slot in the keel plank. If the galvanising looks sound in this area then it is likely that the rest of the plate is OK.

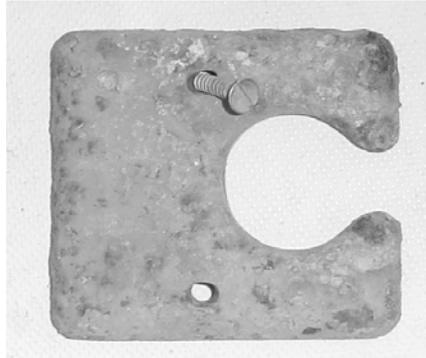
Figure 2 A corroded rudder bearing

The potential problem area is the lower bearing, above the keel plank. On older boats the cast iron is likely to have badly corroded. If the boat has been used with a fixed rudder then the lower bearing will have taken the brunt of any impacts and it is likely to have become detached above the keel-plank. Test to see if this is the case by crawling beneath the boat and inserting a finger at the forward end of the rudder slot. You should be able to feel the metal of the bearing and it will be easily moved if loose. A loose lower bearing can result in the rudder pivot damaging the GRP of the trunking. It is an extremely difficult job either to re-attach or replace the lower rudder bearing, as the keel-plank has either to be displaced or removed completely.
